PHASE I INSPECTION REPORT
NATIONAL DAM SAFETY PROGRAM

BEARPAW LAKE DAM
HILL COUNTY, MONTANA
MT - 115

Christian, Spring, Sielbach & Associates
Bozeman, Montana

Seattle District
United States
Army Corps of Engineers

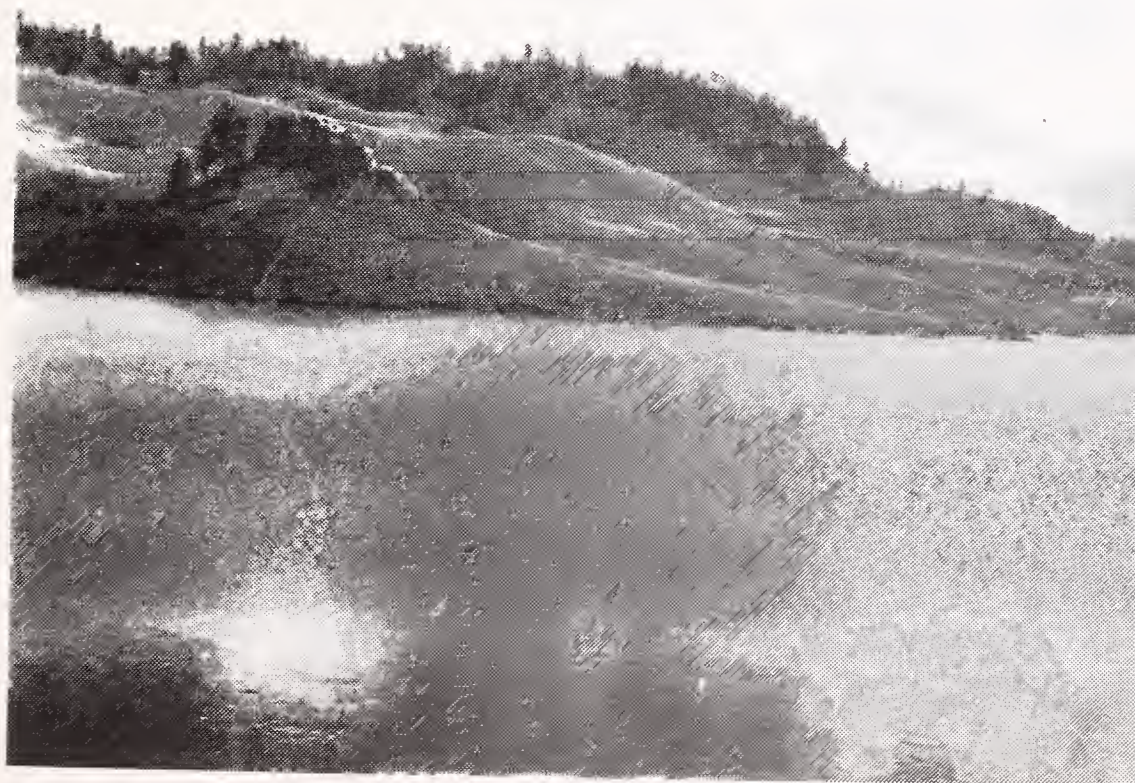
PHOTO 7 - Just downstream from conduit outlet
showing seepage (dark line area left side photo)
outlet for 8" diameter drain

At the downstream toe a small seepage area was noted just above the conduit outlet. (Photo 7) Further investigation revealed that this seepage area is the exit point for an 8-inch concrete drain pipe, shown on the "as-built" plans. The drain pipe follows the trough of the downstream toe from the right abutment and terminates just above the conduit outlet. The drain was installed at the time of construction, and reportedly drains a

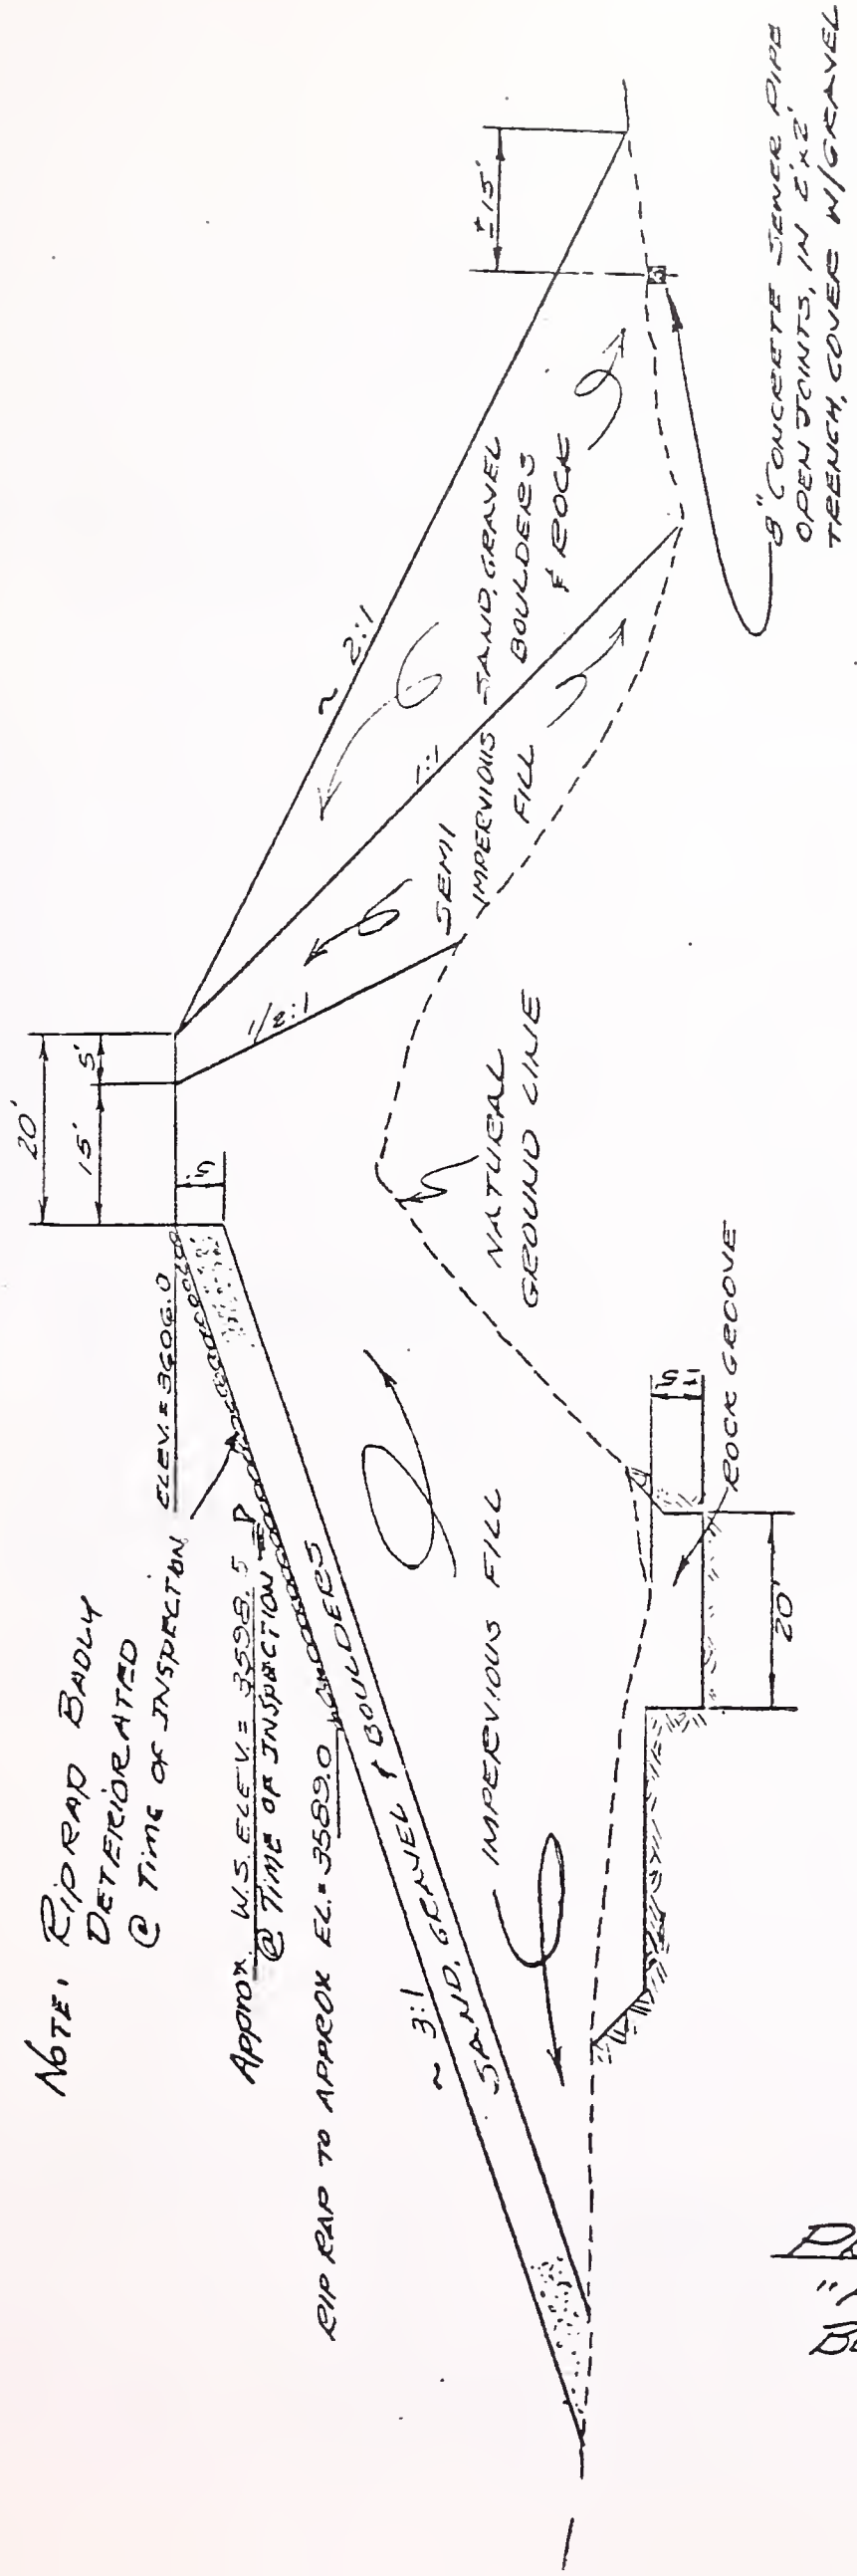
TYPICAL SECTION

typical section of the dam is shown on Plate 5. The relative strengths, density, permeability and drainage characteristics of the zoned embankment are unknown, as are construction methods utilized.

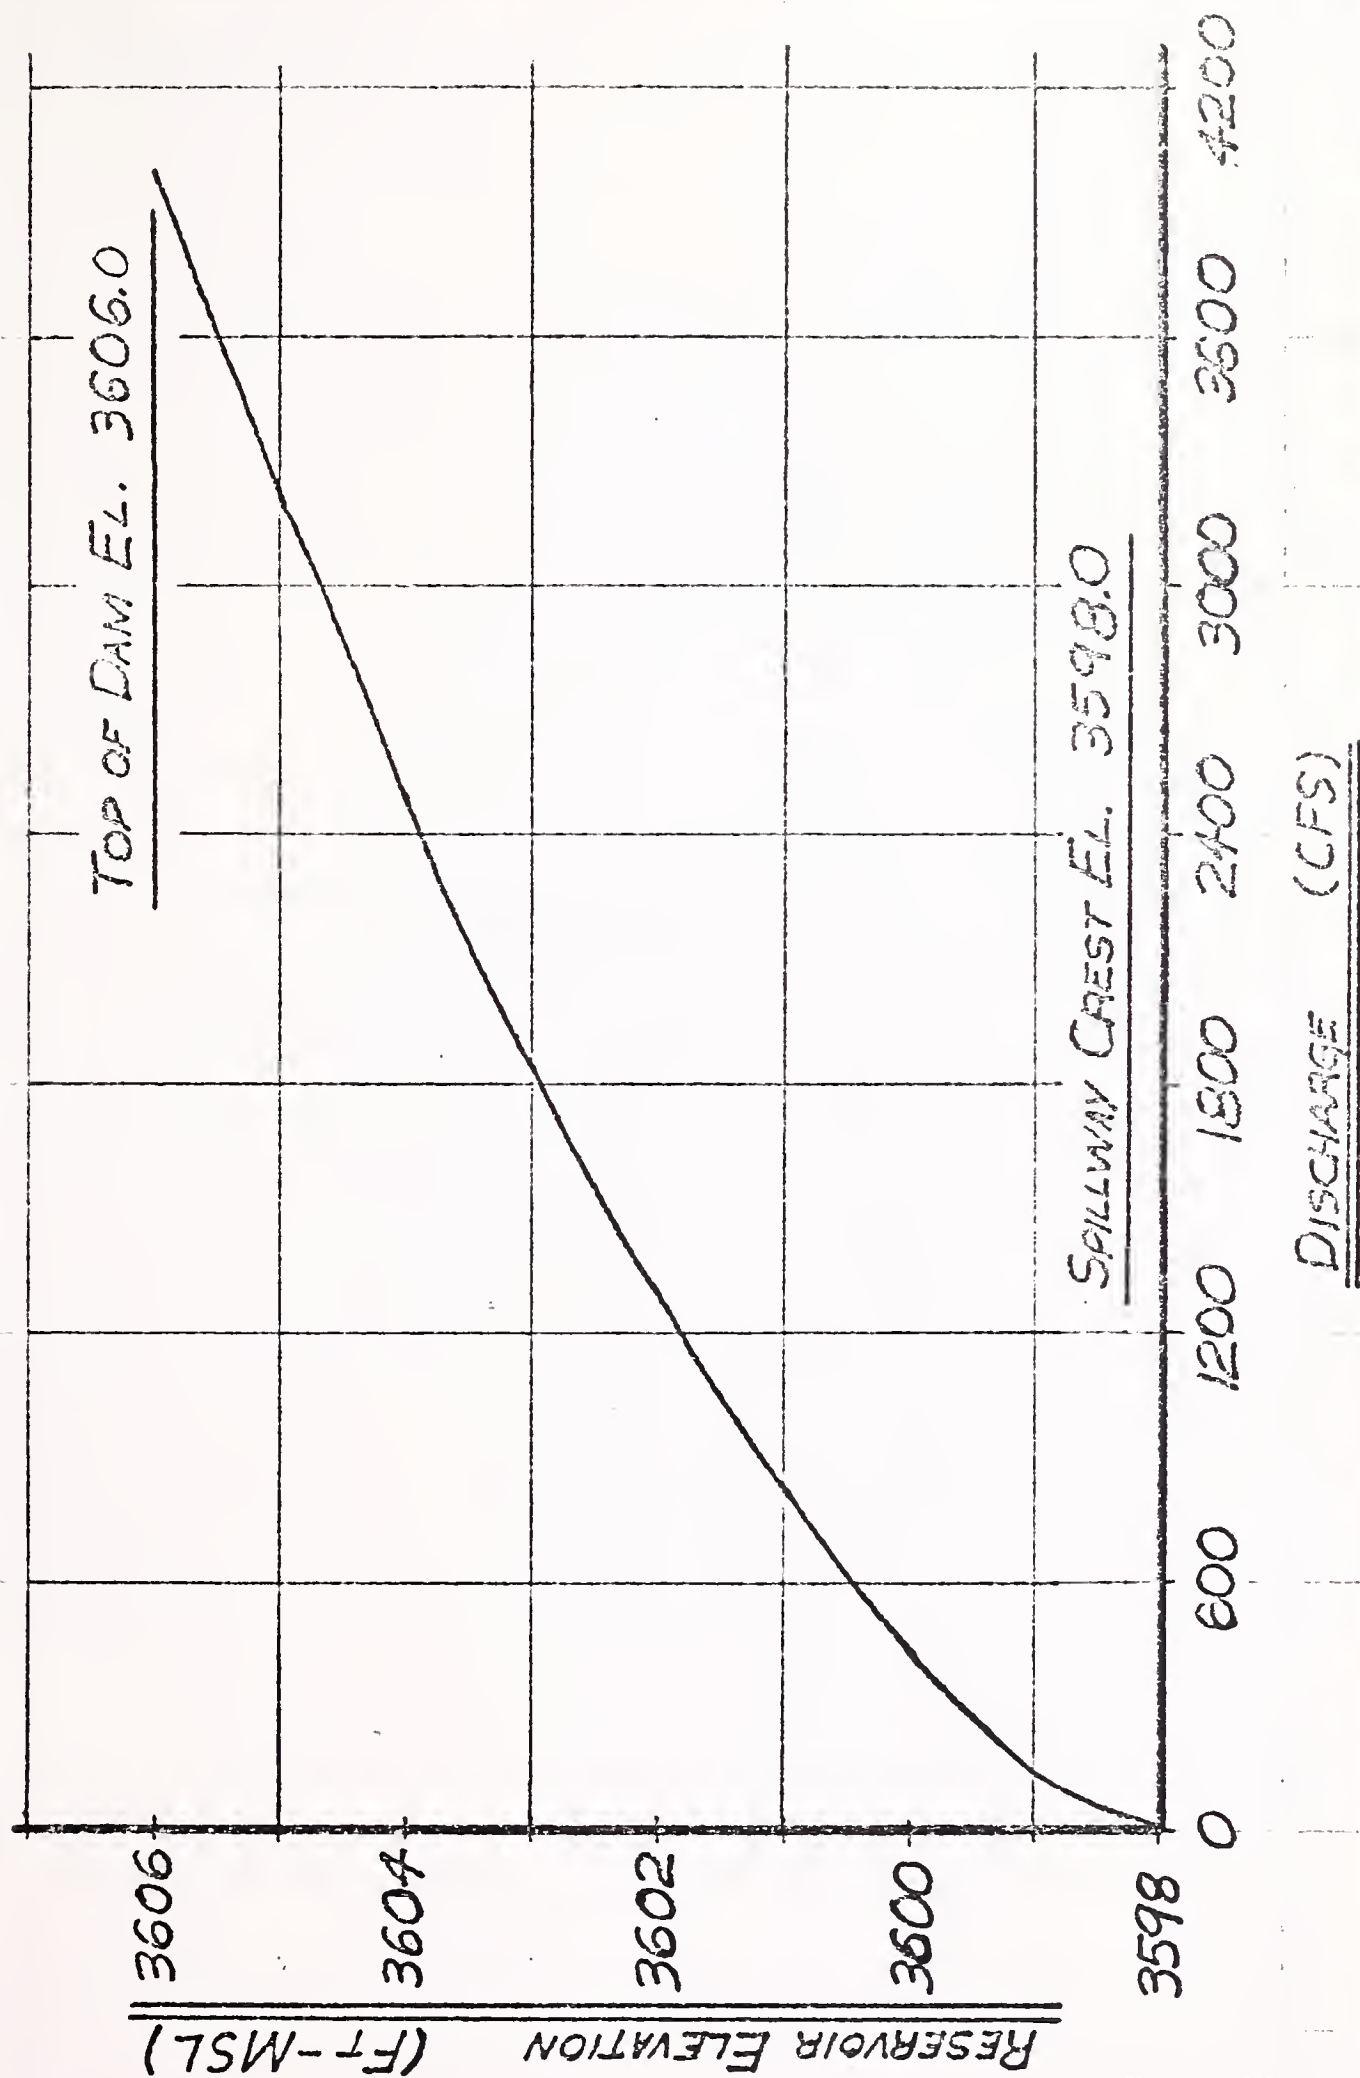
PLATE 8

The reservoir has a surface area of 36 acres and a storage of 535 acre-feet at emergency spillway crest, elevation 3598.0 feet M.S.L. Approximately 370 acre-feet of surcharge storage is available in the reservoir between the emergency spillway crest and the dam crest elevation 3606.0 feet M.S.L. The chute spillway discharge with the reservoir at dam crest is about 3980 c.f.s. A spillway discharge rating curve is shown on Plate 8.
